UKDIVEWORKS

Conditional Survey

Location: XXXXXXXXXX

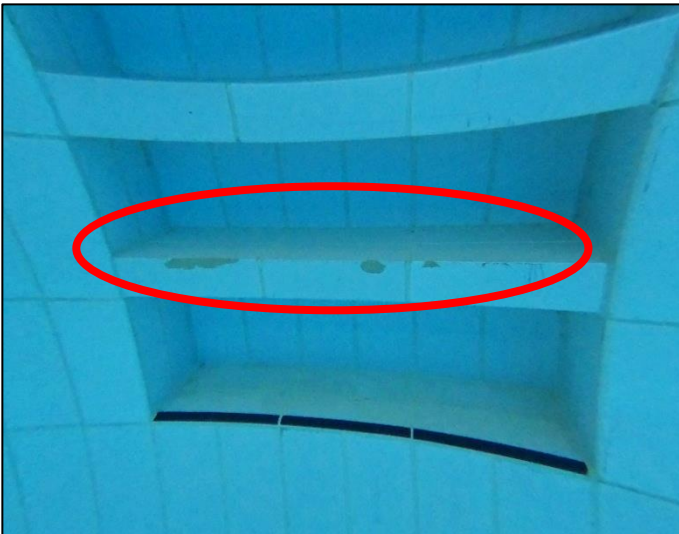
There are 8 integrated ladders that serve the entry and exit needs of pool users. A surface mounted handrail is installed on poolside at each ladder location. These hand rails were secure and all fixings were present. Below surface, inspection of the step treads took place and it was found that large delamination and chipping has occurred to the step treads of the integrated ladders. This is extremely hazardous to pool users as full body weight will be placed on these step treads and there are sharp edges present.

Photo 1: Chipped step tread – hazardous to pool users

Recommendation 1: High Priority – Screed in epoxy resin to ladder treads to eliminate sharp edges and make safe.

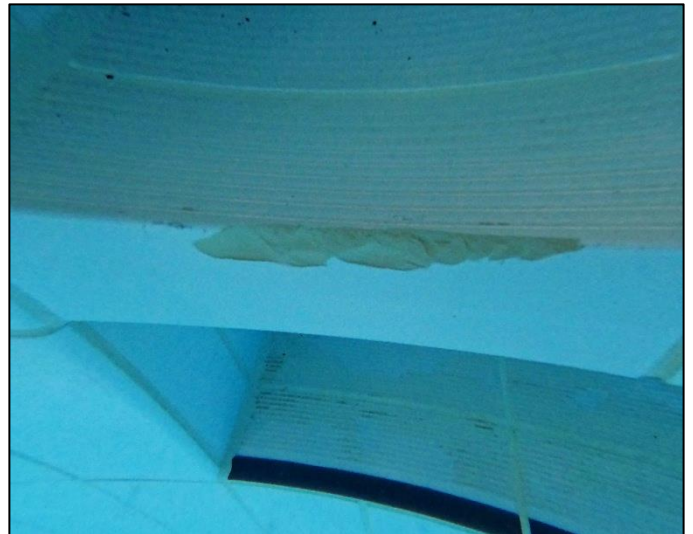
Photo 2: Close up of chipped step tread

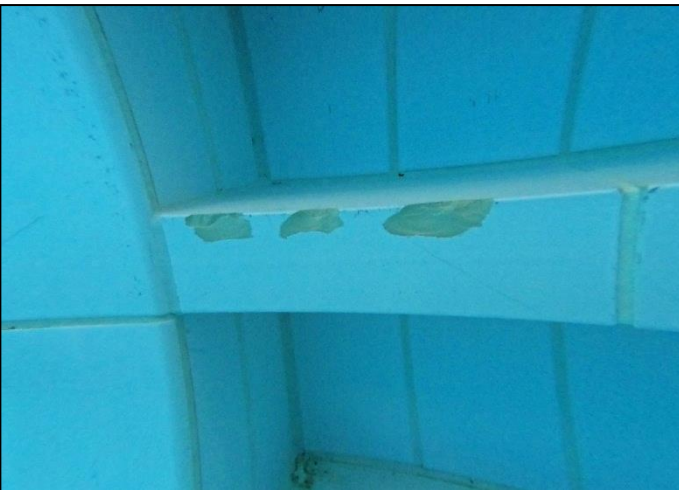
Photo 3: Badly chipped steps

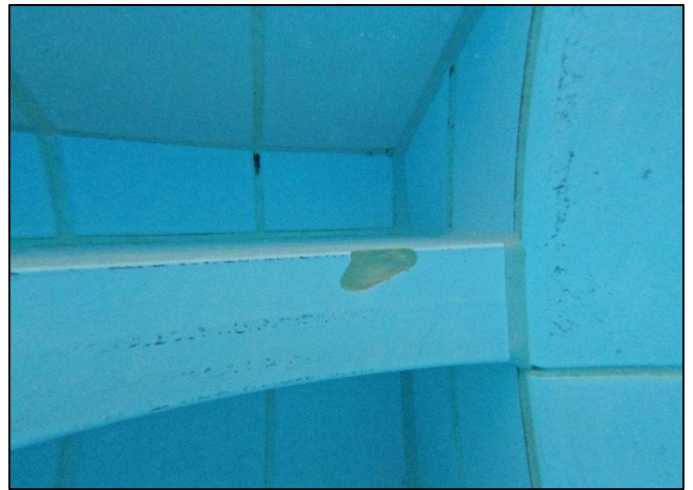
Photo 4: Further chipped steps

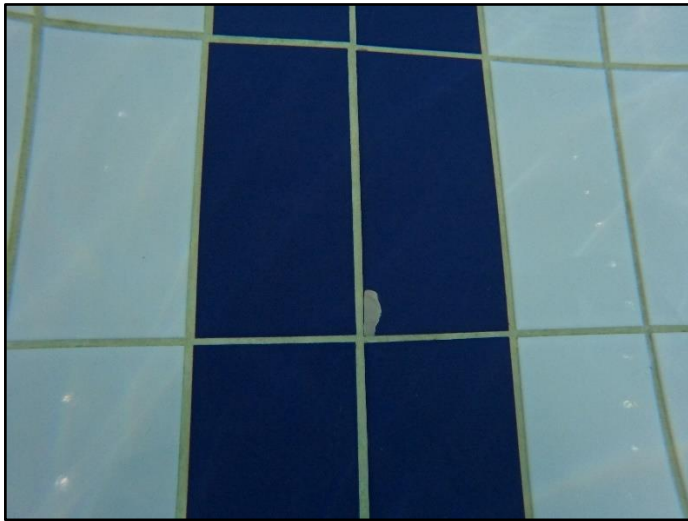
Photo 5 – Chipped tile within main pool tank

Recommendation 2: High Priority – Using underwater epoxy resin, re-screed material in to areas of missing grout. Also screed epoxy resin over the chipped areas on the steps to eliminate sharp edges.

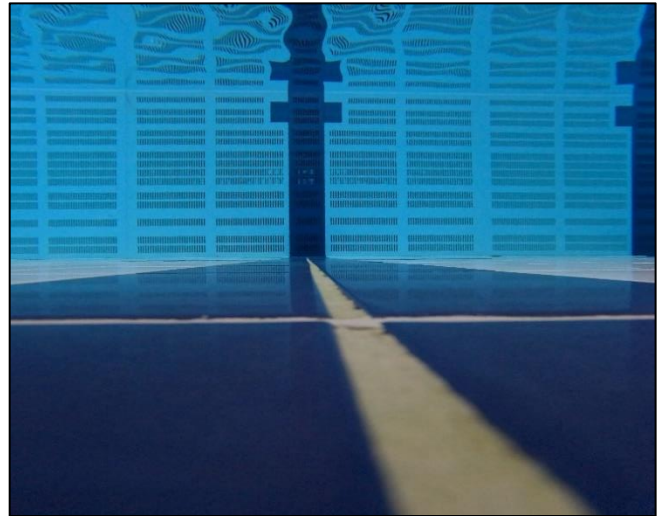
The pool grout has suffered depletion of approximately 2mm which is an acceptable level without any rectification works required. An area of 10 cms was identified as needing to be re-filled due to complete grout loss.

Photo 6 – Minimal grout loss throughout the pool

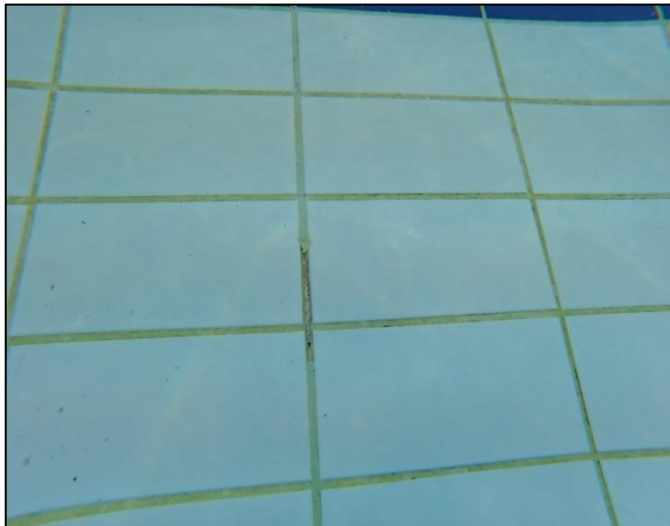
Photo 7: Grout has turned yellow in majority of areas

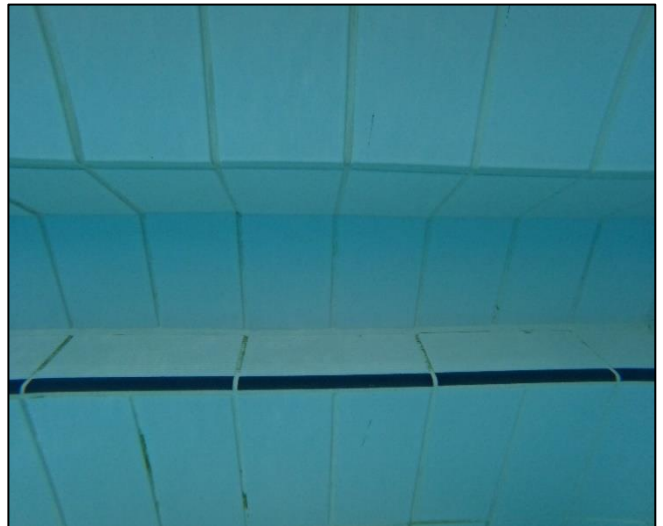
Photo 8: Foot hold ledge – tiles in good condition

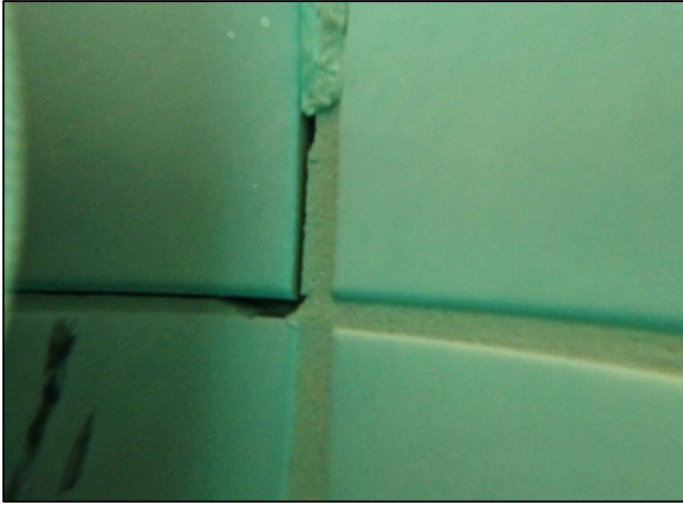
Photo 9 – Missing grout next to boom on wall

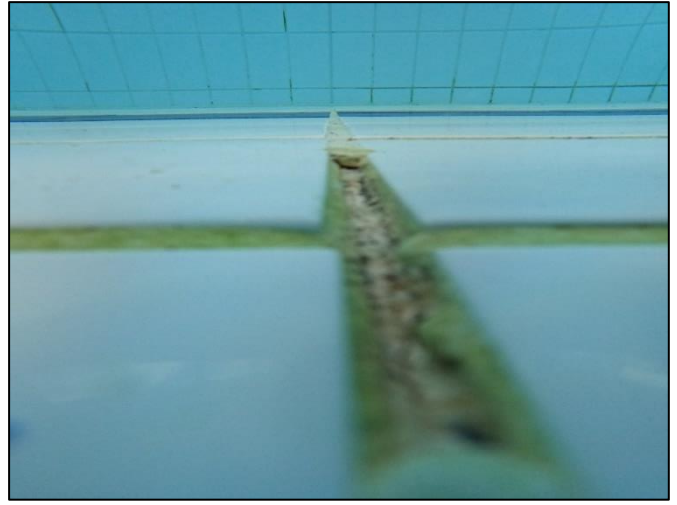
Photo 10 – 10cm area of missing grout

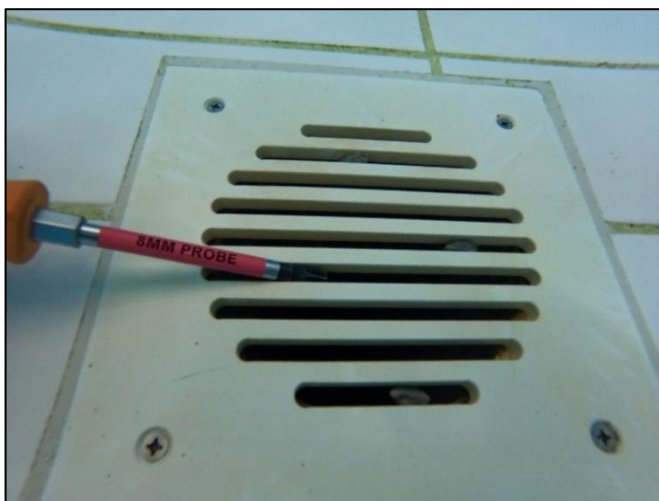
All grilles comply with HSG179 document. This is in reference to the 8mm rule. All grilles and plastics were probe tested to ensure that these gaps did not exceed the parameters of the guidance document. All grilles were secure and no fixing were missing.

Photo 11 – Probe test completed to floor grilles

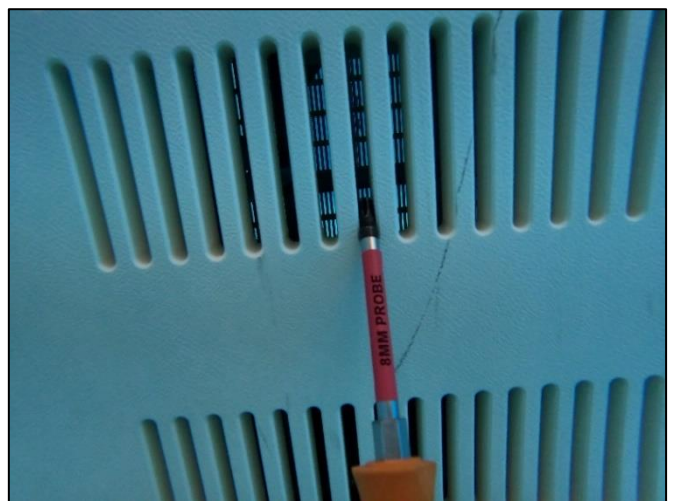
Photo 12 – Probe test to boom plastic apertures

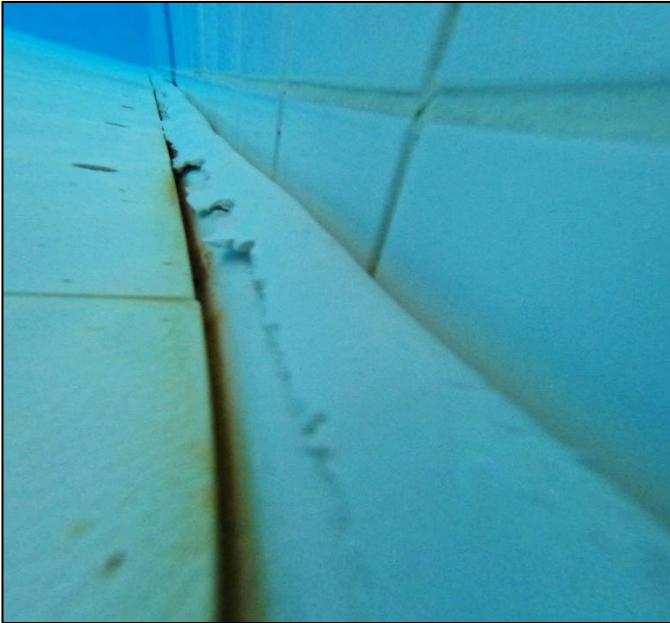
The “P Strip” that serves the edge of the moving floor to ensure no gaps are present has suffered splitting, crushing and is in a defected state. This requires removal and installation of new p strip.

Photo 13: Perished P strip

Recommendation 3: High priority – Re-instate missing fixings to access hatches of boom, remove damaged “p strip” and re-install new to eliminate the perished, split and crushed existing strips. Install an additional plastic strip to each vertical corner of the boom to close 50mm gap (this will need further investigation to ensure that the boom will not catch on the way up and down).

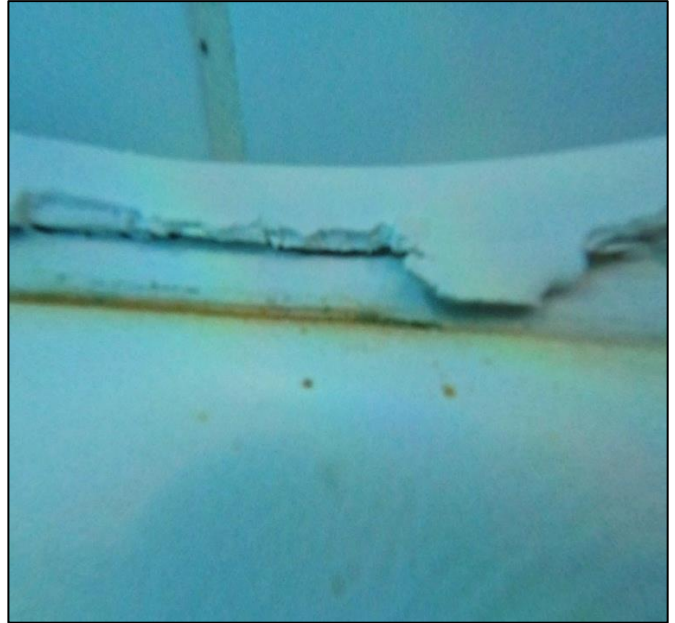
Photo 14: Split P strip

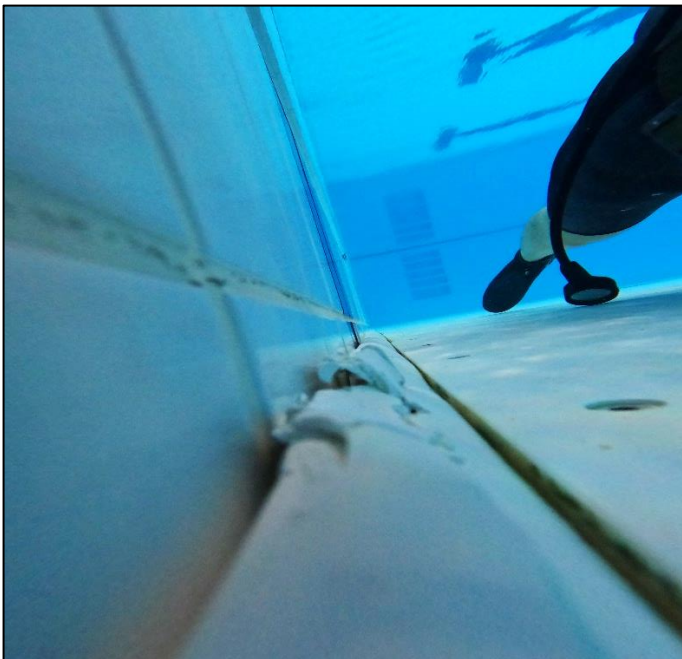
Photo 15: Further P strip Damage

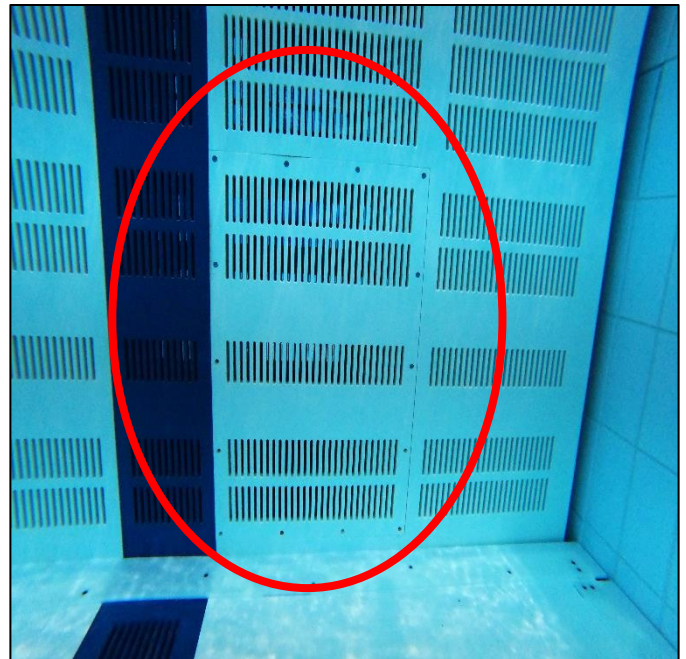
There were approximately 34 missing securing screws to the boom access hatches which require replacement.

Photo 16: Access hatch to boom missing securing bolts

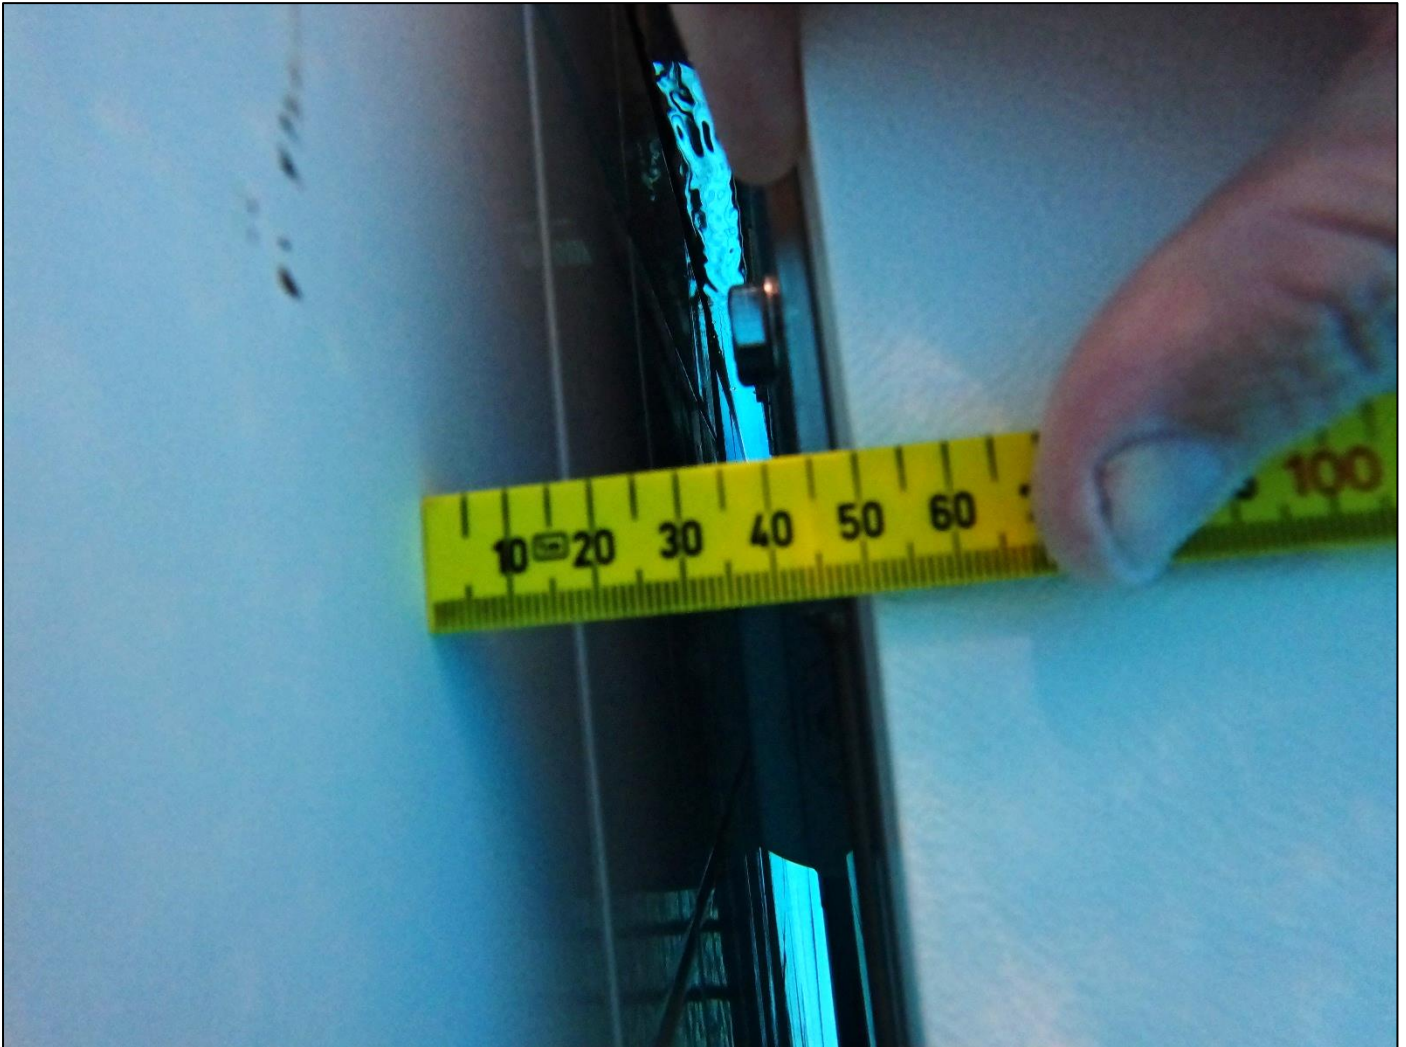
Plastics relating to the booms and moving floors were in good condition. However there were gaps exceeding 50mm to every vertical boom edge where it meets the pool wall. This is a non conformance and requires remedial works to rectify.

Photo 17: 50mm gap between pool wall and boom at 8 locations (Every corner of the 2 booms)

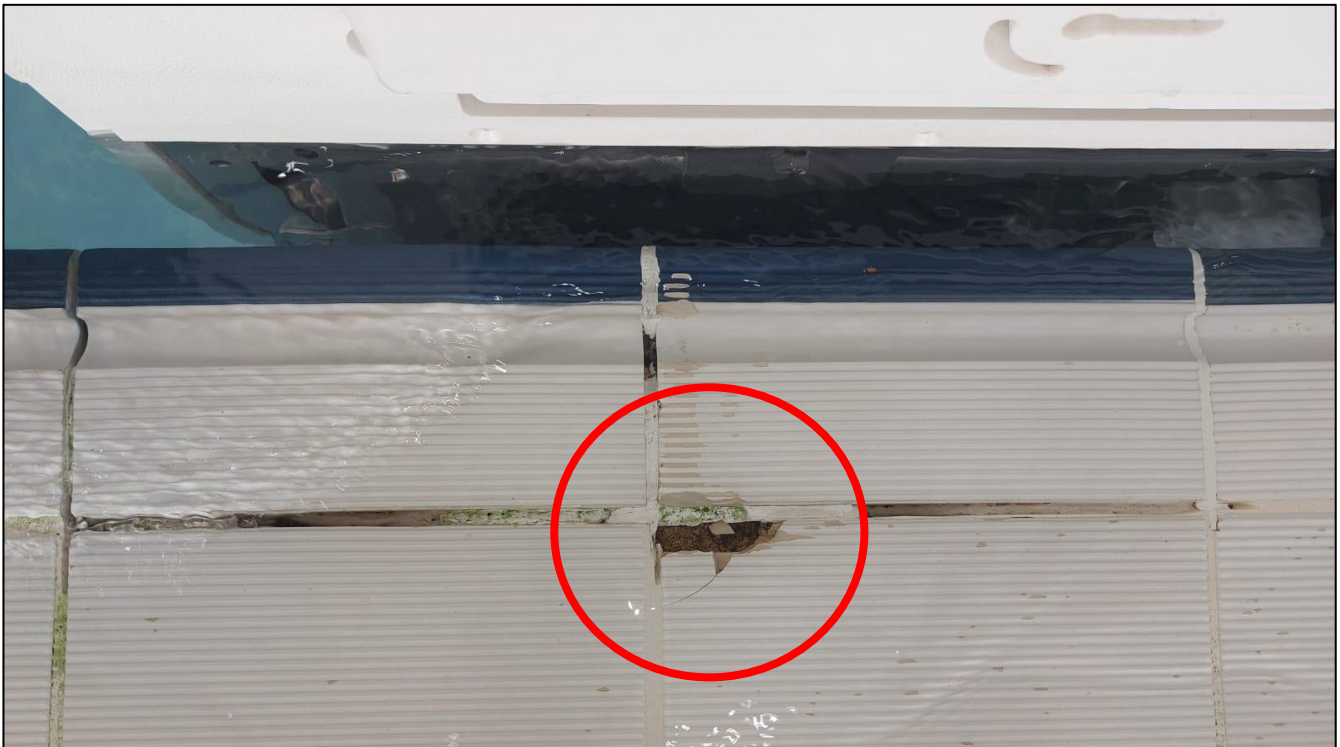
The poolside tiling has defects which need to be rectified as soon as possible as these pose a cutting hazard to pool users. Chipped hand grip tiles, splintered tiles adjacent to the hand grip tiles and chipped tiles are present.

Photo 18: Damaged tile adjacent to hand grip tile alongside the boom

Recommendation 4; High Priority – Remove badly damaged tiles and install new using epoxy resin. Screed in epoxy resin to chipped tiling to make safe. Install new sections of overflow channel to ensure no gaps exceed 8mm. Screed in red epoxy resin to missing grout areas.

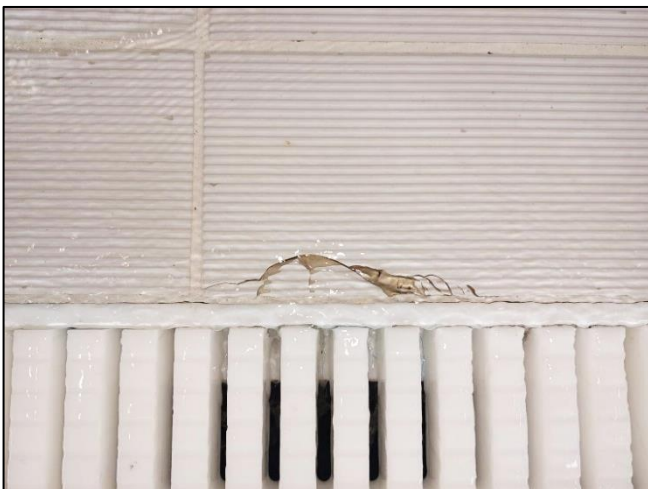
Photo 19- Splintered tile – sharp edges exposed

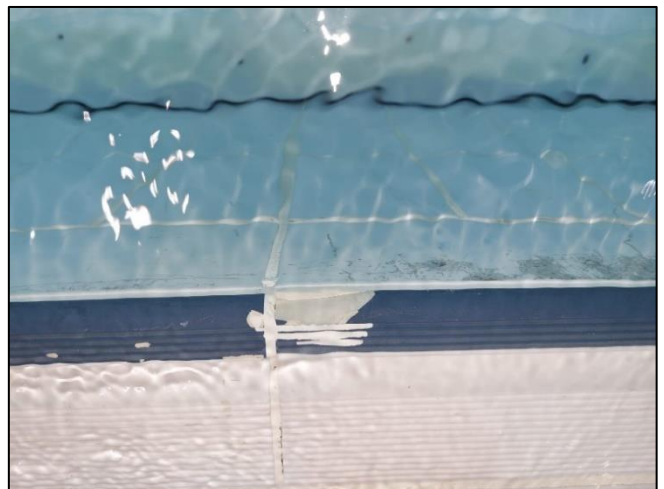
Photo 20: Chipped finger grip tile – cutting hazard

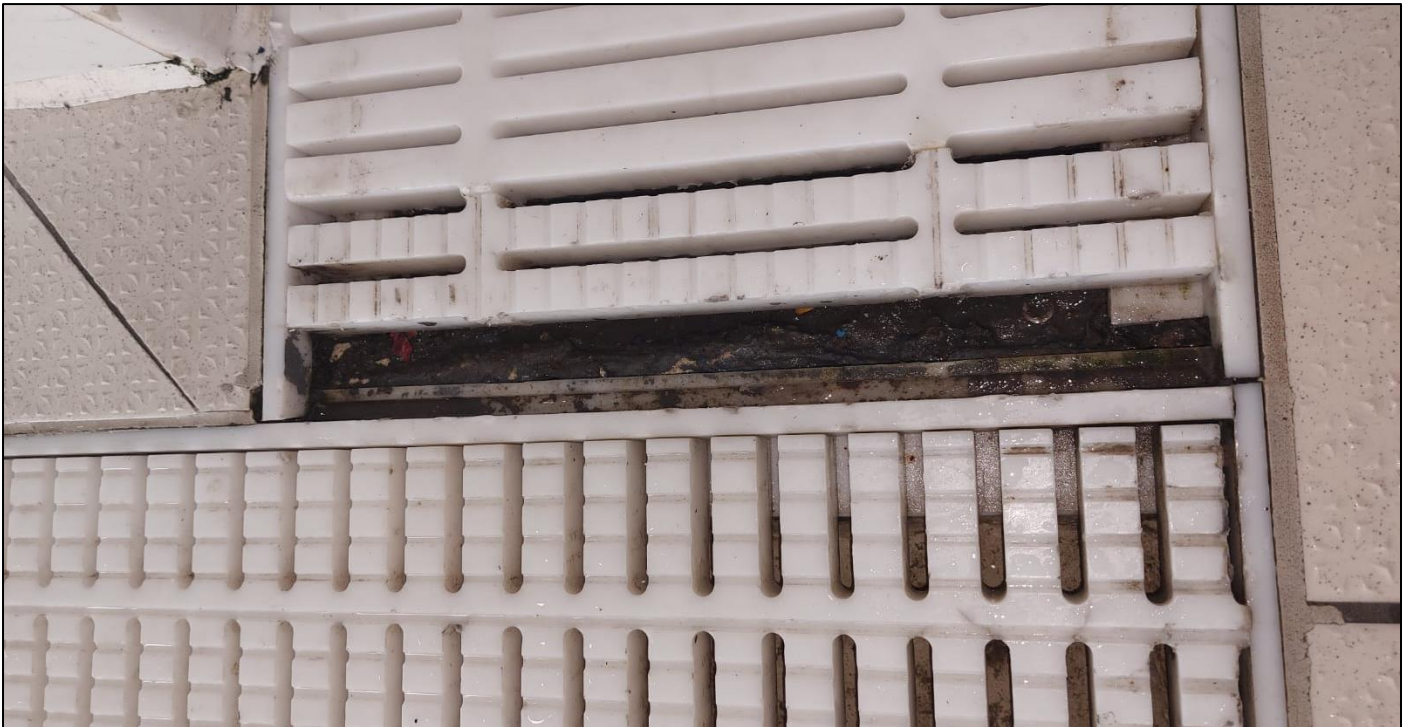
The poolside is laid to non slip tiling. There is an overflow channel which has HDPE plastic overflow grating installed. The overflow grating measures 350mm wide x 30mm deep and is white. Upon inspection of the overflow channel grating, it was found to have missing sections which do not conform to HSG179 8mm rule. It also poses as a tripping hazard along with the potential for broken toes and ankles. The overflow channel grating requires replacement within the areas that have gaps.

Photo 21: Missing overflow channel – tripping hazard

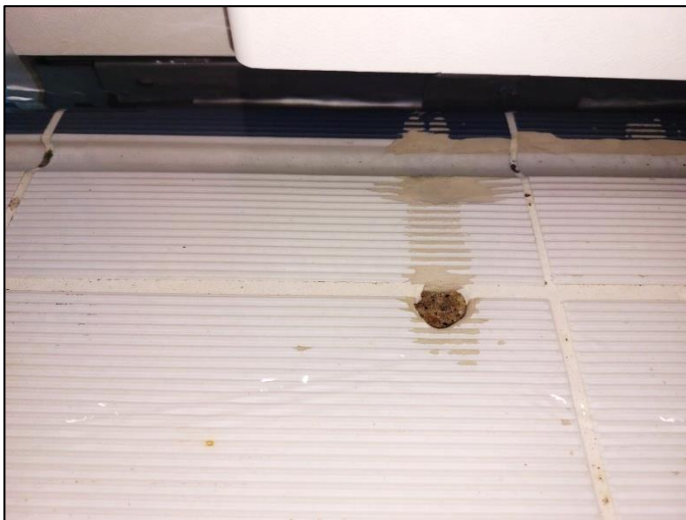
Photo 22: Hole within pool surround tiling

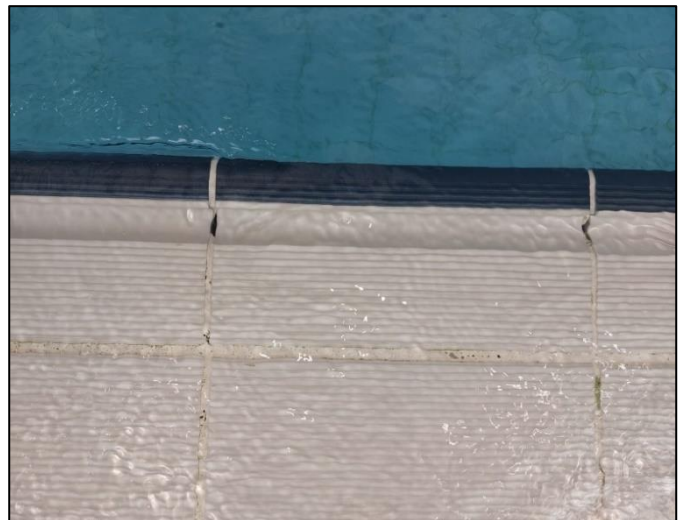
Photo 23: grout missing around poolside (1%)

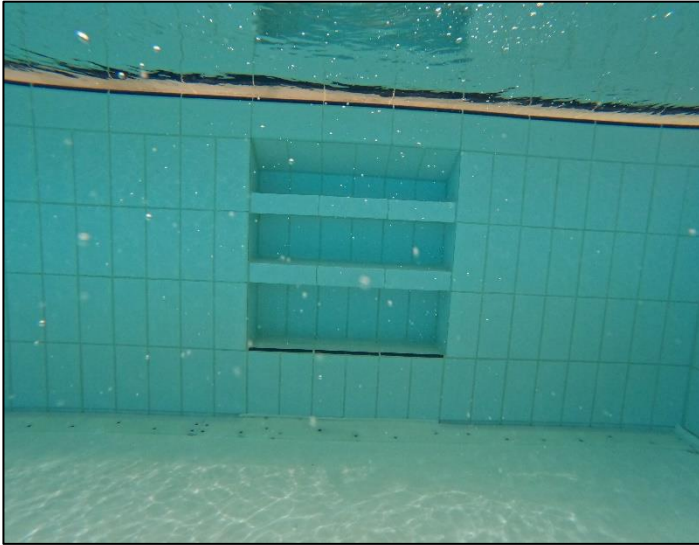
The learner pool has a total of 4 ladders serving the entry and exit points of the pool. These ladders were in good condition and showed no signs of defect or danger to pool users. All poolside hand rails were checked and all fixings are present and secure.

Photo 24: Overview of integrated ladders

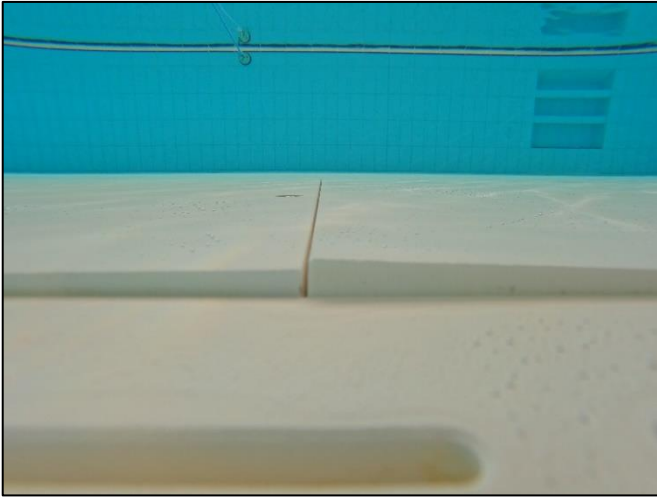
The Plastic panels within the pool moving floor are uneven in places and require re-fixing down to make them flush. The P strip has been crushed and is missing in areas to the circumference of the pool moving floor. This is exposing gaps that exceed 8mm and require to be rectified in line with HSG179.

Photo 26 – Uneven plastic panelling

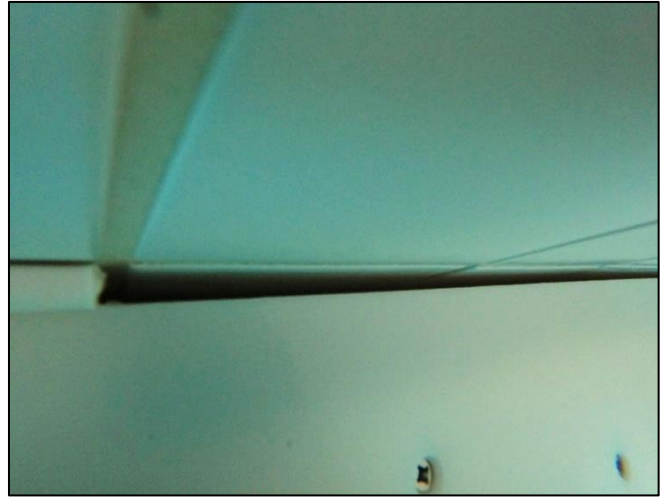
Photo 27 – Missing P Strip – gap exceeding 8mm

Recommendation 5: High priority – Remove damaged “p strip” and re-install new to eliminate the perished, split and crushed existing P strips.

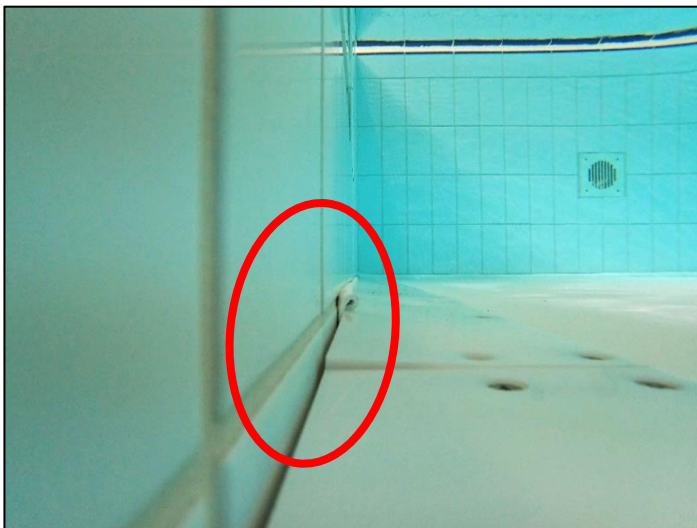
Photo 28: P strip squashed and missing

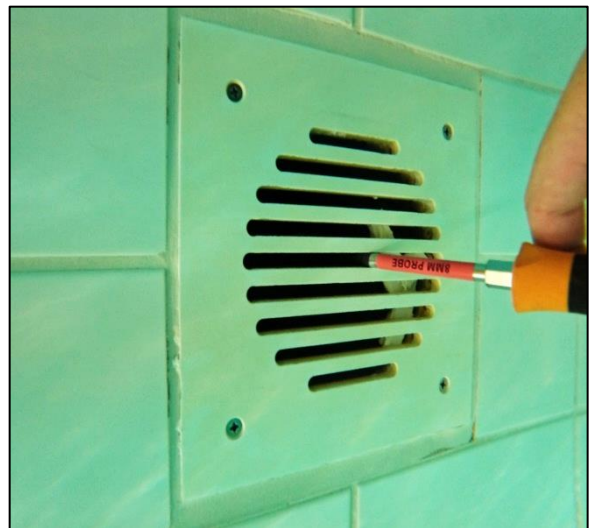
Photo 29: Wall inlets passed probe test

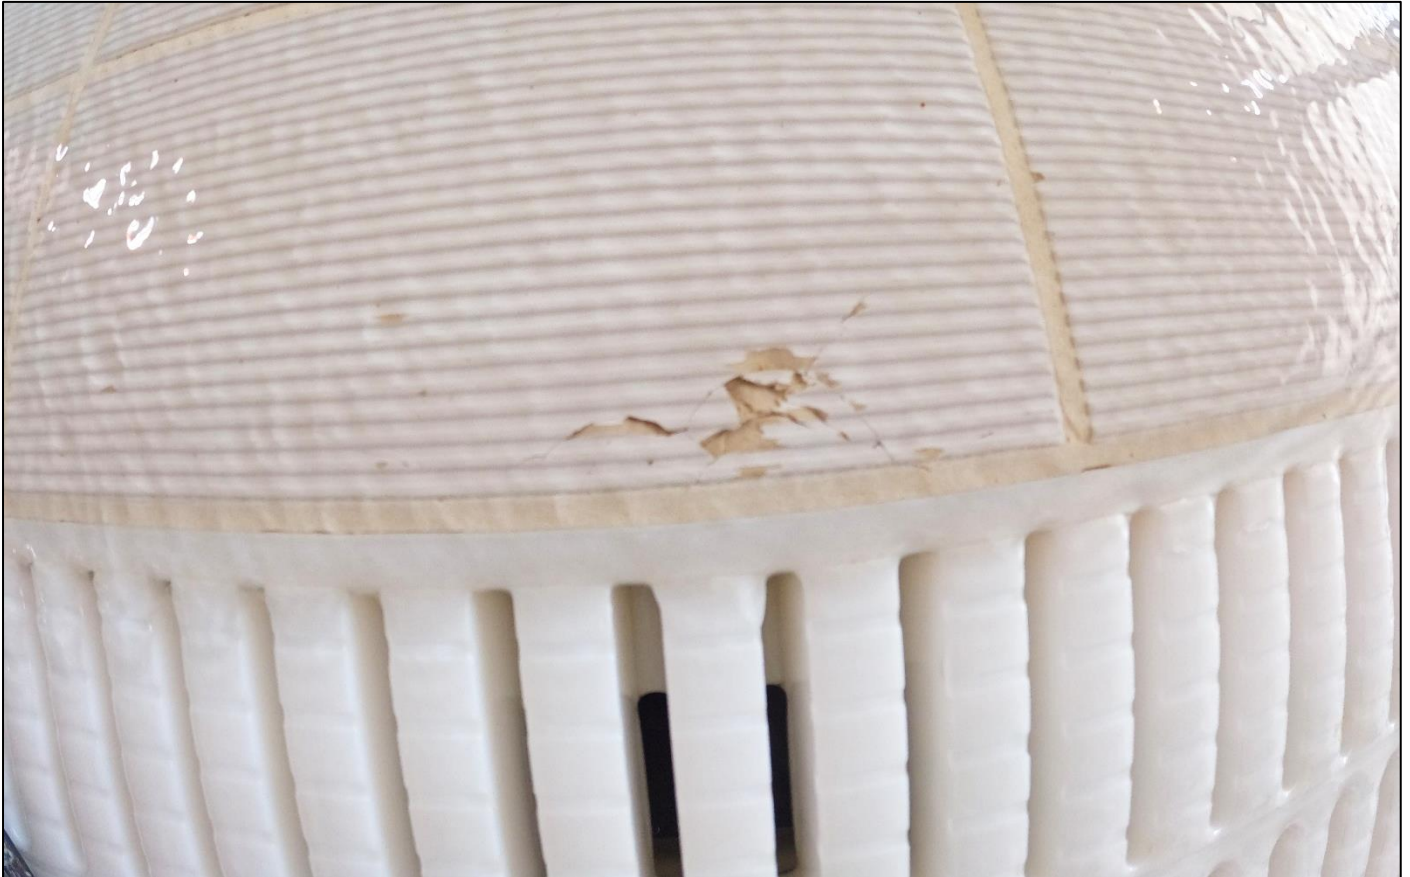
The poolside tiling is in very good condition with only 1 tile found to be defective. This tile requires making safe or removal and replacement.

Photo 30: 1 single tile with defect on poolside surround

Recommendation 6: High Priority - Remove defective tile and replace with new using epoxy resin. Reinstatement missing areas of grout,

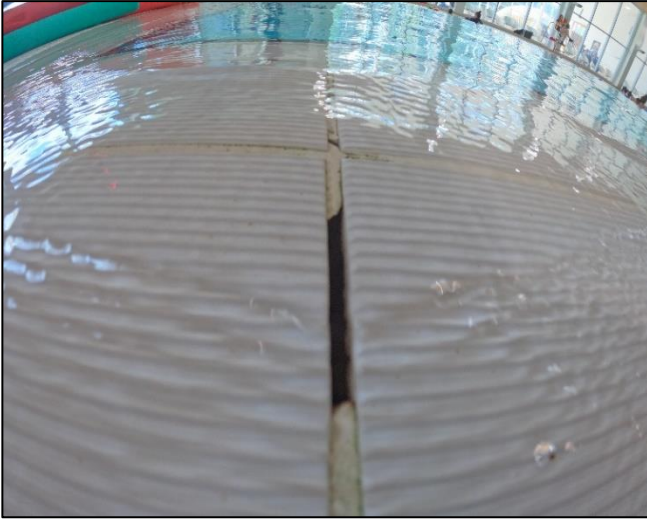
Photo 31: Missing grout – requires reinstatement

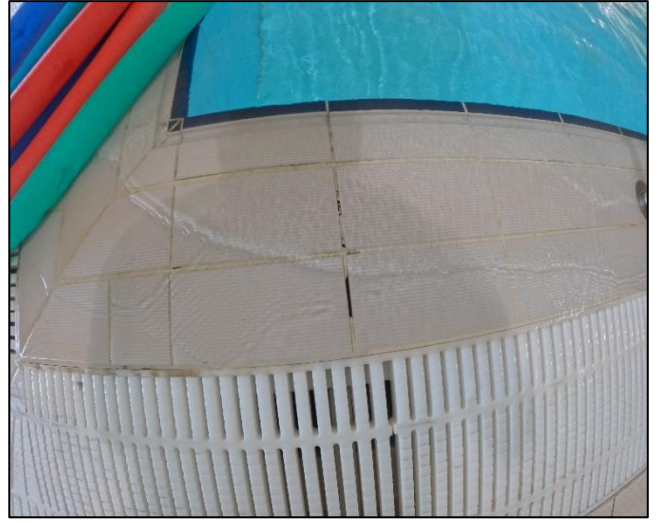
Photo 32: Missing grout overview

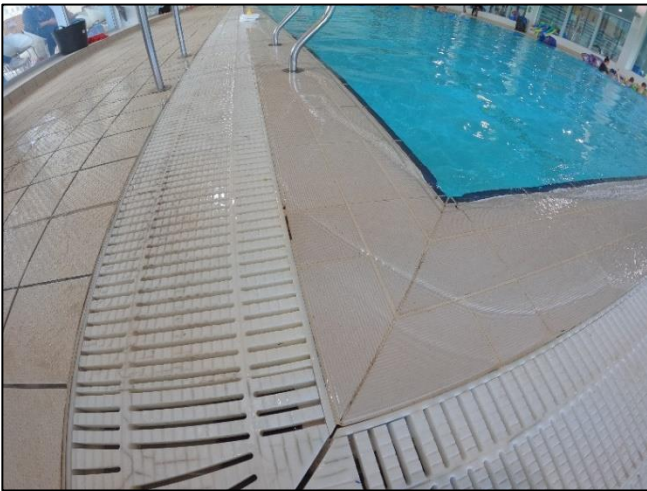
Photo 33: Overflow channel grating in good condition

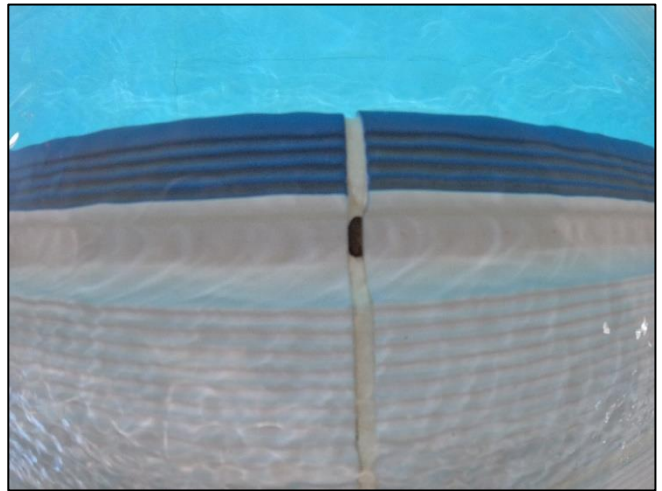
Photo 34: Missing grout within fingergrip tiles
